# **TSE Team Report**

## **Osgoode Interlocking Incident Report**

**February 3, 2021**

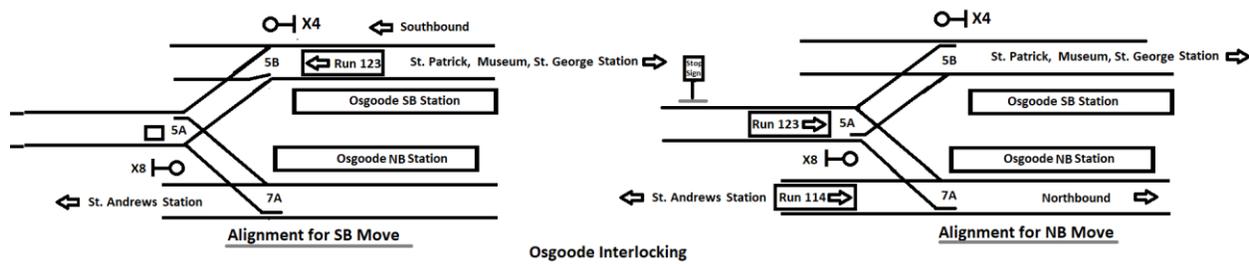
The events leading up to this incident started on June 11<sup>th</sup>, 11.53 p.m. and continued to 12:10 a.m. June 12<sup>th</sup>, 2020, and are summarized as follows:

- The facing point switch 5A, into Osgoode northbound, changes direction, as it is the other end of the southbound switch 5B for the move into the storage track; this is required for the next southbound move into Osgoode Station (this is this a normal condition).
